National Transportation Safety Board
Washington, D.C. 20594

Highway Accident Brief

Accident No.: HWY-03-MH-018
Accident Type: Vehicle loss of control, followed by sideswipe collisions with tractor-semitrailer
Location: Amsterdam Road (State Route 347), west of Belgrade, Montana
Date and Time: January 23, 2003, 3:20 p.m.

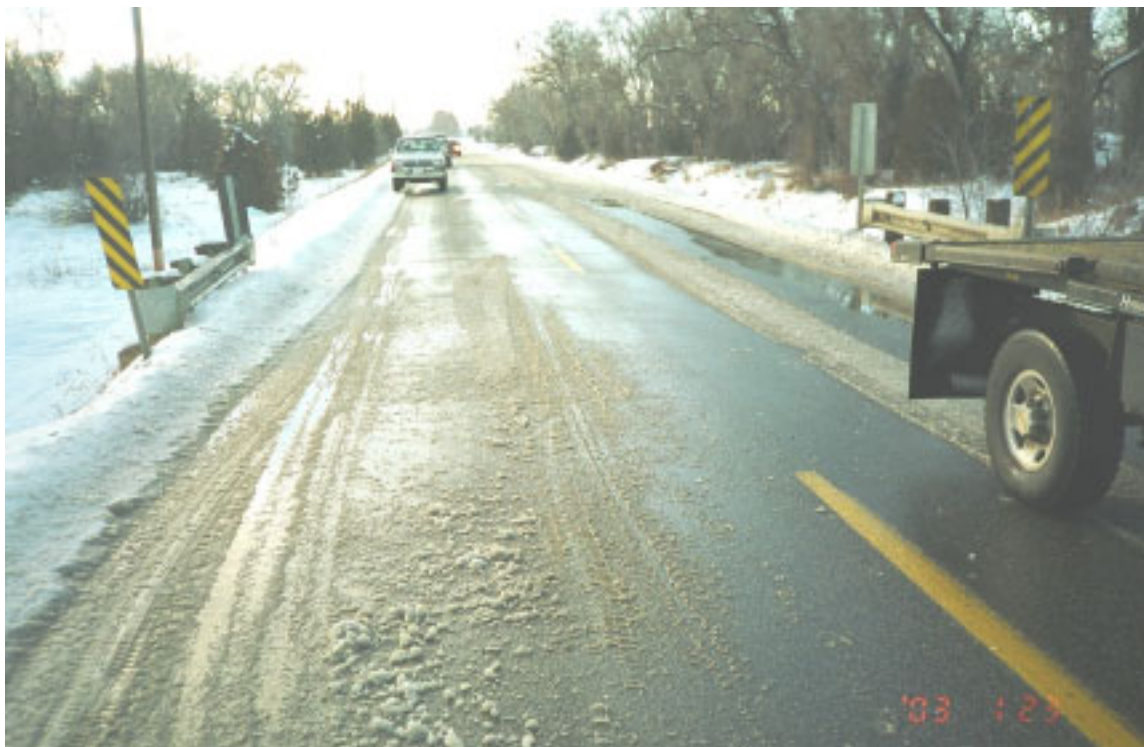
Figure 2. Roadway conditions at the accident scene. (Source: Montana Highway Patrol)

In the vicinity of the accident site, Amsterdam Road is a straight, level, undivided roadway consisting of two 11-foot-wide lanes, variable-width shoulders, and grassy ditches sloping away from the shoulders. The road was intermittently bordered on the south by tall trees that cast shadows on the roadway. The posted speed limit was 70 mph in the daytime and 65 mph at night. Approximately 60 feet west of the accident site was a short, 22-foot-wide bridge over a ditch. The sides of the bridge consisted of W-beam barriers marked by 12-inch object markers on each end; each marker extended about 6 inches into the roadway (see figure 2).

Time sheets for the Gallatin County Road and Bridge Department, which is responsible for snow removal, included several entries on January 23 for Amsterdam Road, indicating “Scrape Ice” and “Plow and Sand.” The time of day for these entries was not noted. Postaccident photographs show an accumulation of ice, snow, and slush on the pavement edges and two clear tire ruts in the slush in each lane, slightly offset toward the center of the roadway (see figure 2). Some standing water had accumulated in puddles along the south side of the roadway.

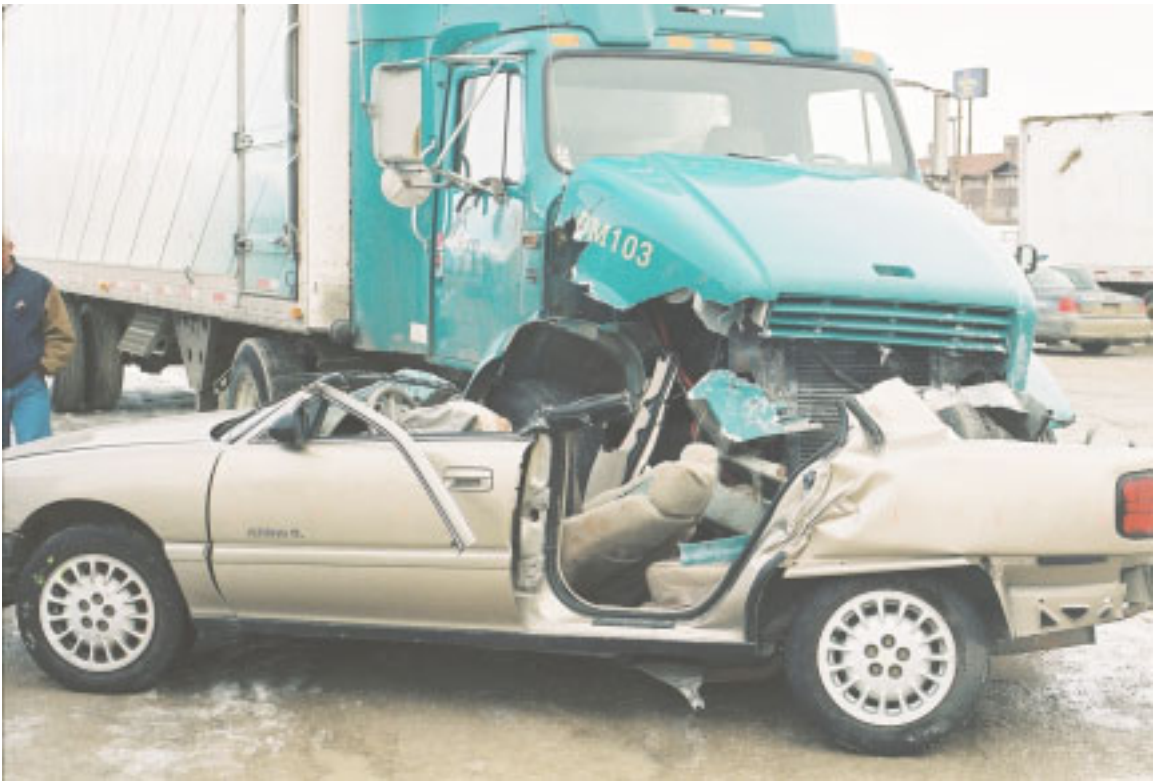
Figure 3. Vehicles aligned postcollision during accident reconstruction.

The Oldsmobile rotated counterclockwise and slid sideways across the centerline, where it was struck by the front of the tractor-semitrailer, and then rotated clockwise and impacted the right-front side of the tractor. The Oldsmobile sustained severe damage to its right side and the tractor-semitrailer sustained minor front-end damage. Intrusion into the Oldsmobile's passenger compartment was 24 inches extending along the right side. All of the passengers were wearing their lap/shoulder belts, and the driver and front passenger airbag deployed. Full autopsies were not conducted, but the coroner determined that all four Oldsmobile passengers sustained fatal injuries from massive blunt force trauma and flail chest⁴ wounds.

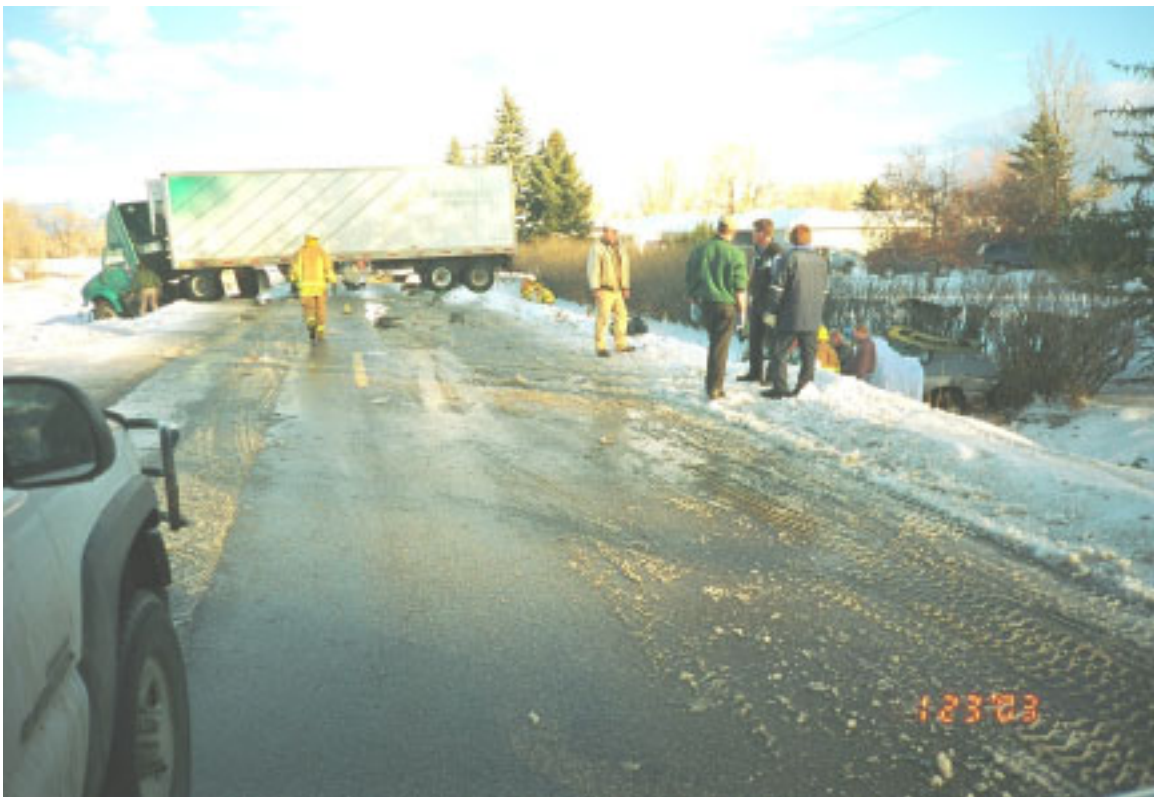
Figure 4. Vehicles at final rest. (Source: Montana Highway Patrol)

About 3:20 p.m. on January 23, 2003, a 1997 Oldsmobile Achieva driver education vehicle was westbound on Amsterdam Road near Belgrade, Montana (see figure 1). A driver education student, age 14 years, 8 months, was driving; an instructor was in the right-front passenger seat, and two other students were seated in the rear seat. About the same time, a 1991 International Truck and Engine Corporation truck tractor with a 1998 Utility Trailer Manufacturing Company semitrailer was eastbound on Amsterdam Road. The weather was clear. Snow earlier in the day had resulted in an accumulation of slush on the roadway in places shaded by patches of trees (see figure 2). The truck driver estimated that his vehicle and the Oldsmobile were traveling 35 to 45 mph. He stated that he saw the oncoming automobile from a distance of more than 100 yards and noticed no indication of a problem. Just after the tractor-semitrailer crossed a short bridge over a ditch, the truck driver said the Oldsmobile began to fishtail and veered into the eastbound lane in front of the tractor-semitrailer. The tractor-semitrailer driver said that he tried to avoid the collision by steering left, but he struck the Oldsmobile on the right side (see figure 3), causing the Oldsmobile to rotate clockwise, strike the right side of the tractor, and then slide down an embankment on the south side of the roadway. The tractor came to rest facing north, blocking both lanes of traffic (see figure 4).
